ERIKS Technical Center	Document No.	
	3856-A Cincinnati Ave	Date	
	Rocklin, CA 95765	Revision No.	
	(916) 408-7295	ERIKS Contact

Title	O-Ring Failure Analysis
-------	-------------------------

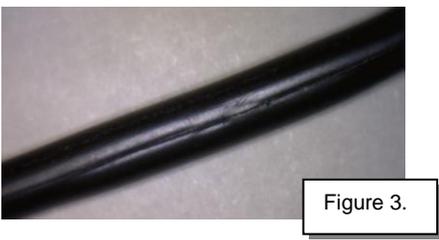
Figure 3.

It also appears that there is an imprint on a section of the o-ring (Figure 3.). This imprint could be caused by a feature on the hardware that is compressing the o-ring.
